Annual Inspection

RSS Playmakers

Abbey Road Playing Field

Annual Inspection - 28 July 2015 at 15:19 Inspector: Richard Goodson RPII Annual Inspector

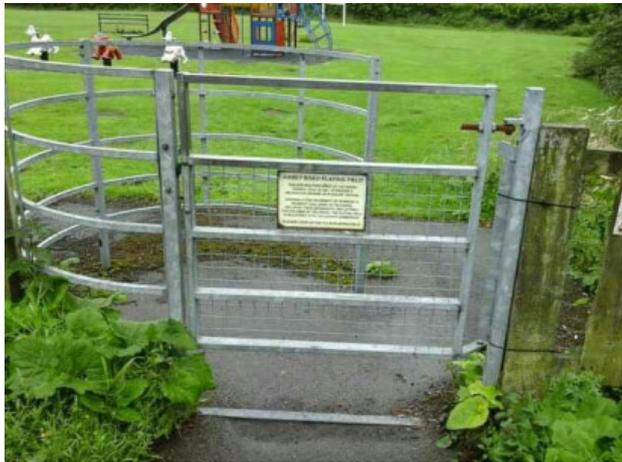
Item: Ancillary Items - Gate - Self Closing
Manufacturer: Owner/Operator
Surface Type: All Weather Surface
Equipment Compliance: N/A
Surface Area Compliance: N/A
Ref/Part Number:
Total Findings: 1

The opening between the gate and the post is less than 12mm and could trap users fingers - Install Buffer on kissing post to ensure a 12mm opening all around

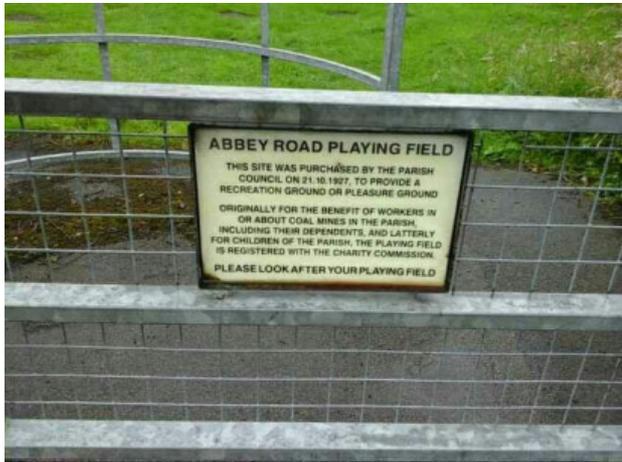
Item: Ancillary Items - Sign
Manufacturer: Owner/Operator
Surface Type: N/A
Equipment Compliance: N/A
Surface Area Compliance: N/A
Ref/Part Number:
Total Findings: 1

It is recommended that information signs with emergency contact details are installed at each entrance/exit point to the playground - Provide in accordance with the recommendations set out in BS EN 1176

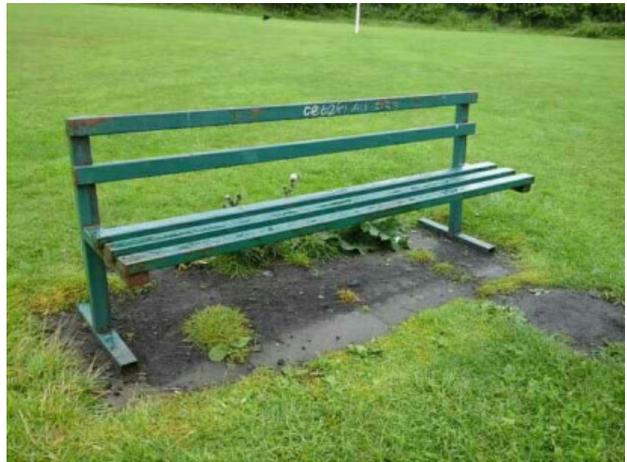
Item: Ancillary Items - Bench
Manufacturer: Owner/Operator
Surface Type: N/A
Equipment Compliance: N/A
Surface Area Compliance: N/A
Ref/Part Number:
Total Findings: 2

There is surface corrosion present on the item - Consider treating and repainting the item

There is some graffiti present - Remove the graffiti

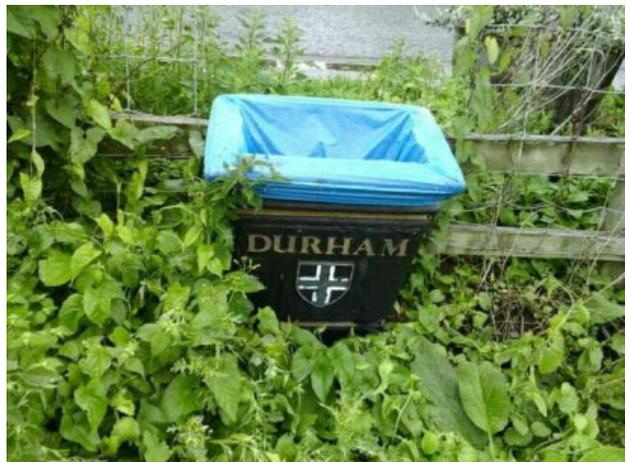
Item: Ancillary Items - Litter Bin
Manufacturer: Owner/Operator
Surface Type: N/A
Equipment Compliance: N/A
Surface Area Compliance: N/A
Ref/Part Number:
Total Findings: 1

Vegetation is overgrowing the items - Cut back vegetation as required

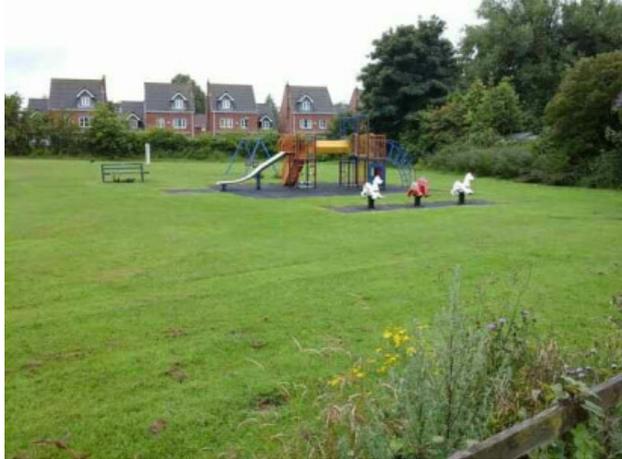
Item: Ancillary Items - Site General
Manufacturer: Owner/Operator
Surface Type: N/A
Equipment Compliance: N/A
Surface Area Compliance: N/A
Ref/Part Number:
Total Findings: 4

There are gaps opening in between the tiles - Monitor for any further deterioration and repair as required

There are weeds/vegetation growth between or around the edges of the surfacing - Remove weeds/vegetation growth

The tiles can easily be lifted or are lifting along the edges of the area - Lift and re-glue tiles to secure

There are trip hazards present on the football pitch - Regulate levels to remove the trip points

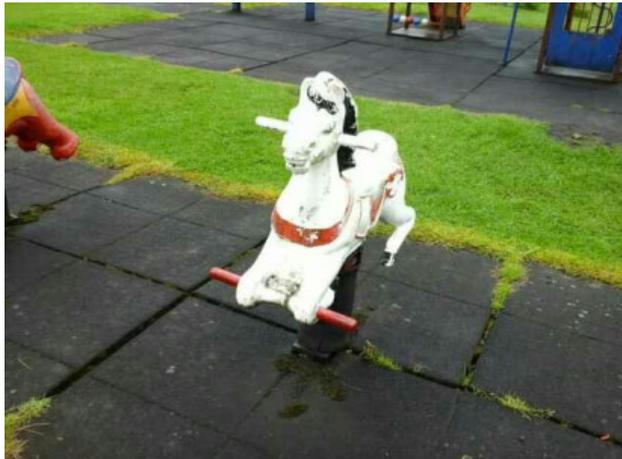
Item: Rocking Equipment - Spring Horse
Manufacturer: Wicksteed Playscapes
Surface Type: Rubber Tiles
Equipment Compliance: No
Surface Area Compliance: Yes
Ref/Part Number:
Total Findings: 2

The end of handgrips and/or footrests have a cross section of less than 15cm² and fail to meet the requirements of BS EN 1176:2008 Part 6 - This is a relatively low risk failure and no remedial action is recommended

The gaiter is damaged - Monitor for further deterioration and replace as required

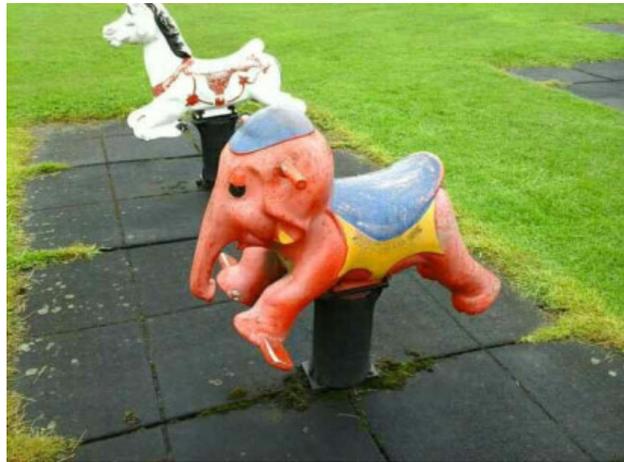
Item: Rocking Equipment - Spring Elephant
Manufacturer: Wicksteed Playscapes
Surface Type: Rubber Tiles
Equipment Compliance: No
Surface Area Compliance: Yes
Ref/Part Number:
Total Findings: 3

The end of handgrips and/or footrests have a cross section of less than 15cm² and fail to meet the requirements of BS EN 1176:2008 Part 6 - This is a relatively low risk failure and no remedial action is recommended

The main body profile has a radius of less than 20mm in places - Monitor Use

The gaitor is damaged - Monitor for further deterioration and replace as required

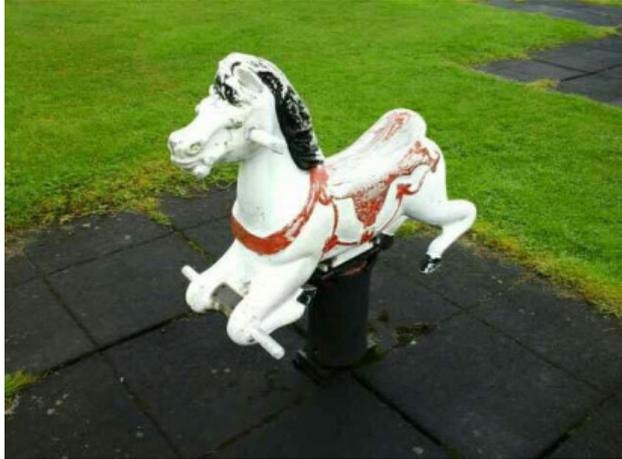
Item: Rocking Equipment - Spring Horse
Manufacturer: Wicksteed Playscapes
Surface Type: Rubber Tiles
Equipment Compliance: No
Surface Area Compliance: Yes
Ref/Part Number:
Total Findings: 2

The end of handgrips and/or footrests have a cross section of less than 15cm² and fail to meet the requirements of BS EN 1176:2008 Part 6 - This is a relatively low risk failure and no remedial action is recommended

The gaiter is damaged - Monitor for further deterioration and replace as required

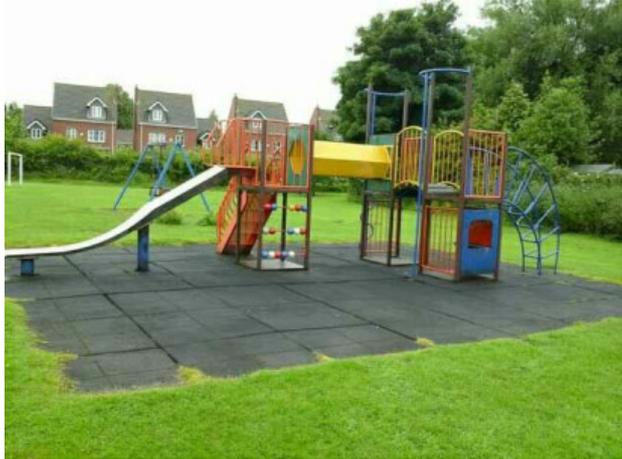
Item: Activity Equipment - Multi Play (Junior)
Manufacturer: Wicksteed Playscapes
Surface Type: Rubber Tiles
Equipment Compliance: No
Surface Area Compliance: Yes
Ref/Part Number:
Total Findings: 7

The item fails to meet the requirements of BS EN 1176:2008 Part 1 4.2.7.2 head and neck entrapment in the barriers and/or steps - Monitor use

This item has no slide bar fitted as required by BS EN 1176 Part 3 - Monitor use

There is/are bolt cap covers missing or damaged on the item - Replace missing or damaged bolt cap covers

There are post caps missing from the item - Replace missing post caps

The tunnel guard panels are damaged/worn - Monitor for further deterioration and replace as required

There is some graffiti present - Remove the graffiti

There is surface corrosion present on the item - Consider treating and repainting the item

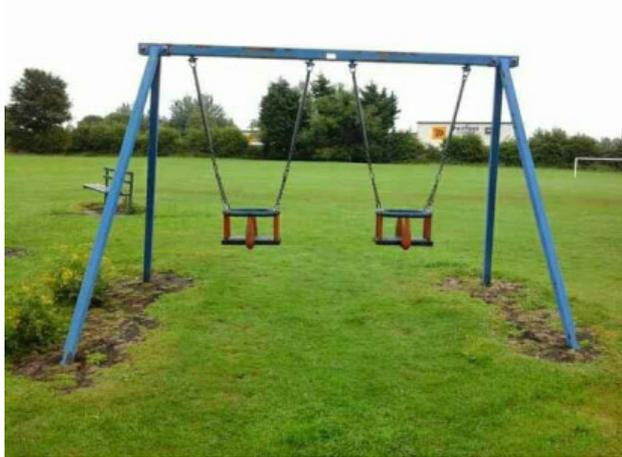
Item: Swings - 1 Bay 3 Seat (Cradle)
Manufacturer: StreetSkapes
Surface Type: Grass Matrix Tiles
Equipment Compliance: Yes
Surface Area Compliance: Yes
Ref/Part Number:
Total Findings: 1

There is surface corrosion present on the item - Consider treating and repainting the item

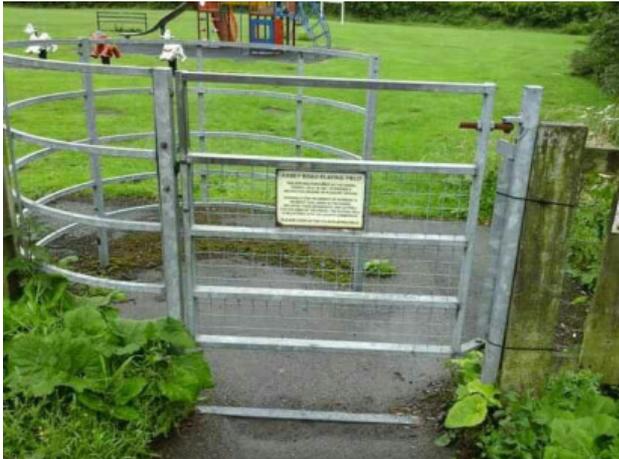
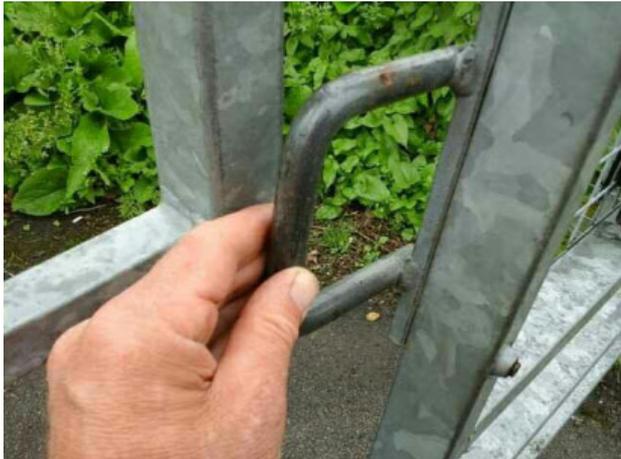
Item:	Ancillary Items - Gate - Self Closing	Risk Level:	L - Low Risk
Manufacturer:	Owner/Operator	Surface:	All Weather Surface

Finding: The opening between the gate and the post is less than 12mm and could trap users fingers

Action: Install Buffer on kissing post to ensure a 12mm opening all around

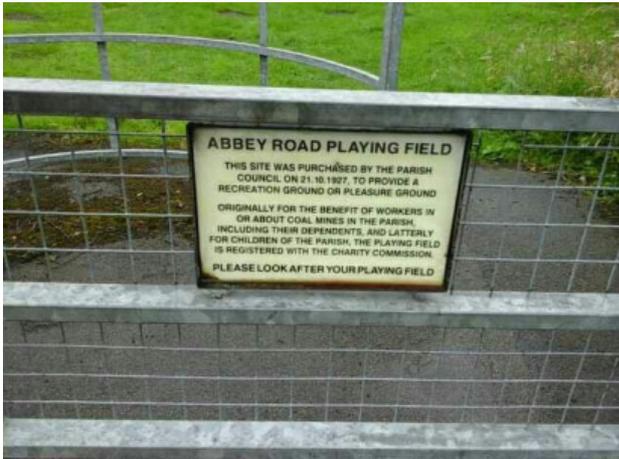
Item:	Ancillary Items - Sign	Risk Level:	V - Very Low Risk
Manufacturer:	Owner/Operator	Surface:	N/A

Finding: It is recommended that information signs with emergency contact details are installed at each entrance/exit point to the playground

Action: Provide in accordance with the recommendations set out in BS EN 1176

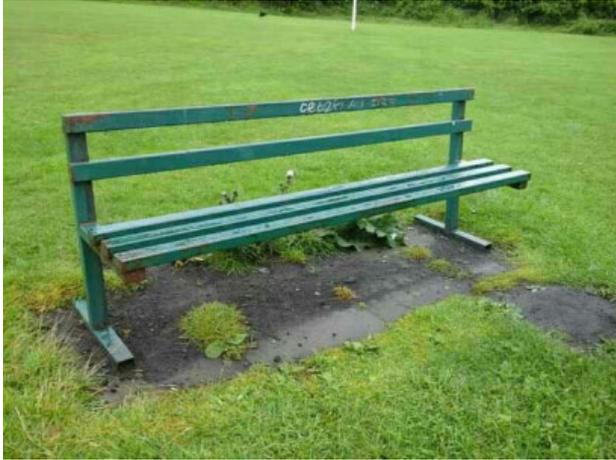
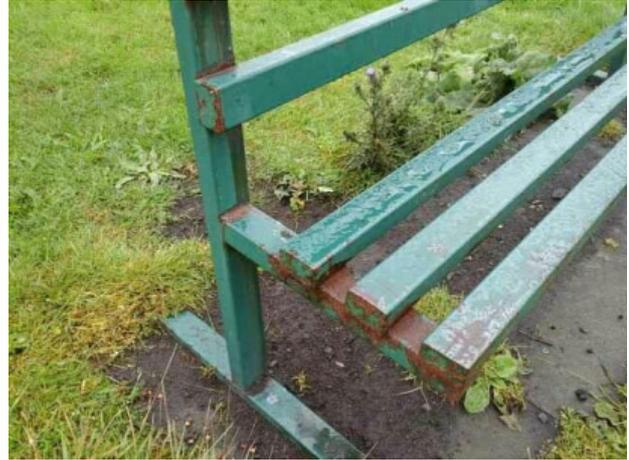
Item: Ancillary Items - Bench
Manufacturer: Owner/Operator

Finding: There is surface corrosion present on the item

Action: Consider treating and repainting the item

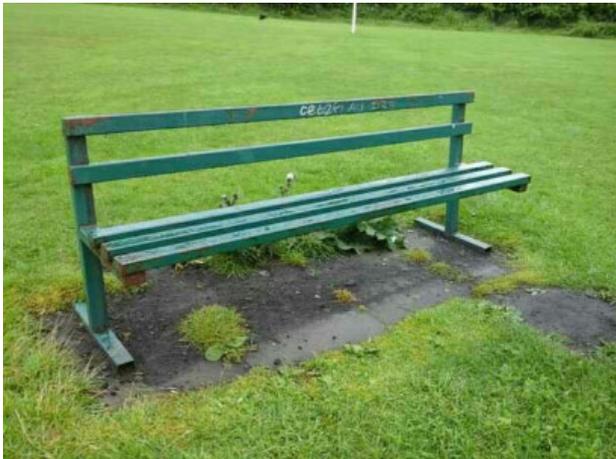
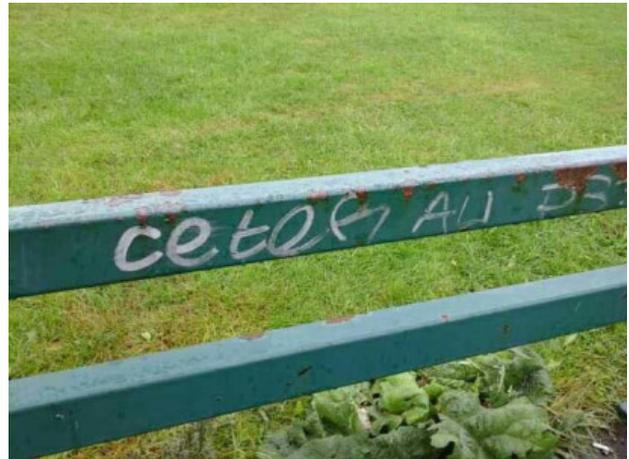
Item: Ancillary Items - Bench
Manufacturer: Owner/Operator

Finding: There is some graffiti present

Action: Remove the graffiti

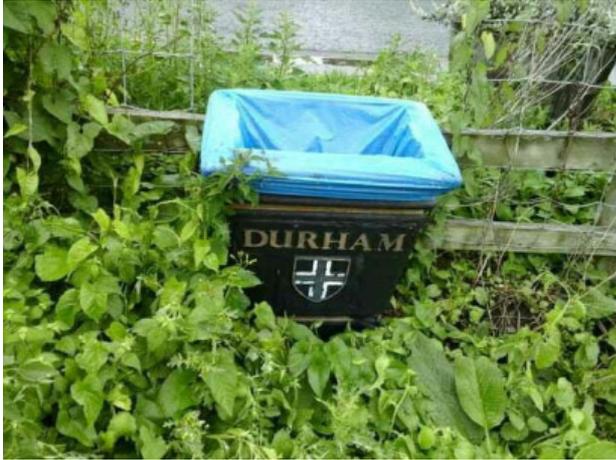
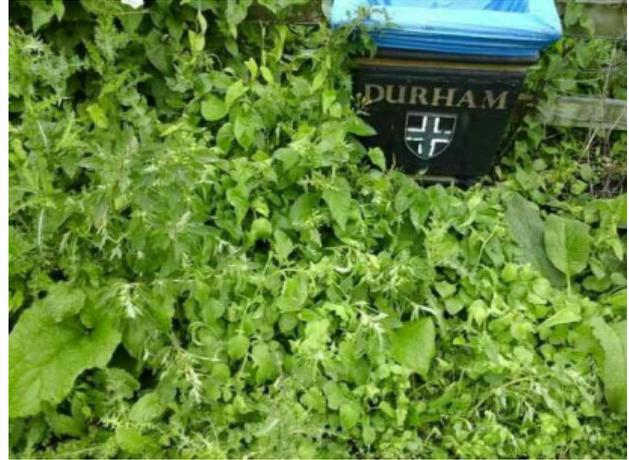
Item: Ancillary Items - Litter Bin
Manufacturer: Owner/Operator

Finding: Vegetation is overgrowing the items

Action: Cut back vegetation as required

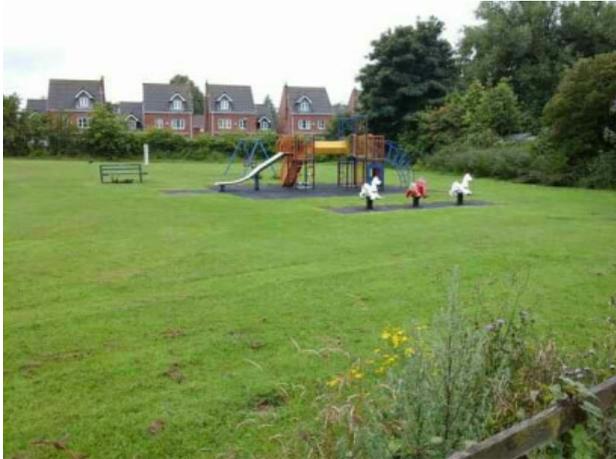
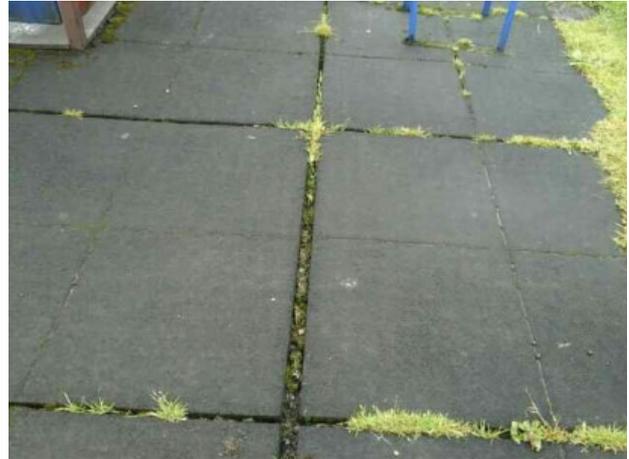
Item: Ancillary Items - Site General
Manufacturer: Owner/Operator

Finding: There are gaps opening in between the tiles

Action: Monitor for any further deterioration and repair as required

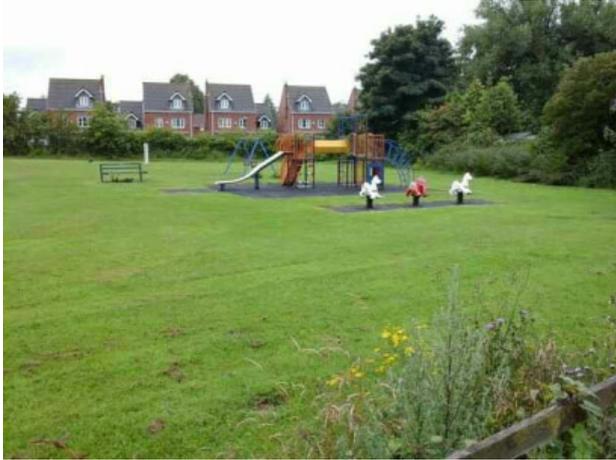
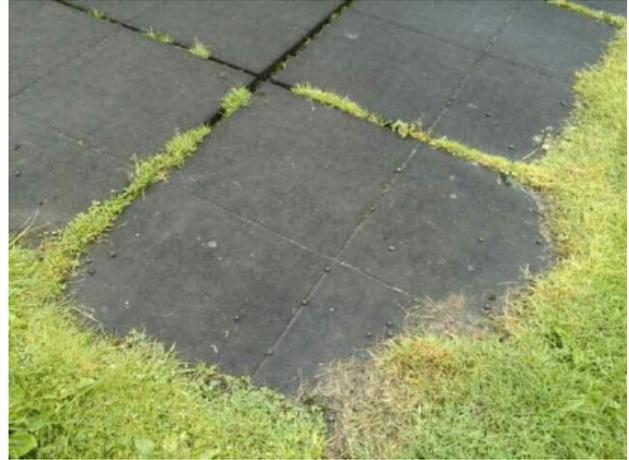
Item: Ancillary Items - Site General
Manufacturer: Owner/Operator

Finding: There are weeds/vegetation growth between or around the edges of the surfacing

Action: Remove weeds/vegetation growth

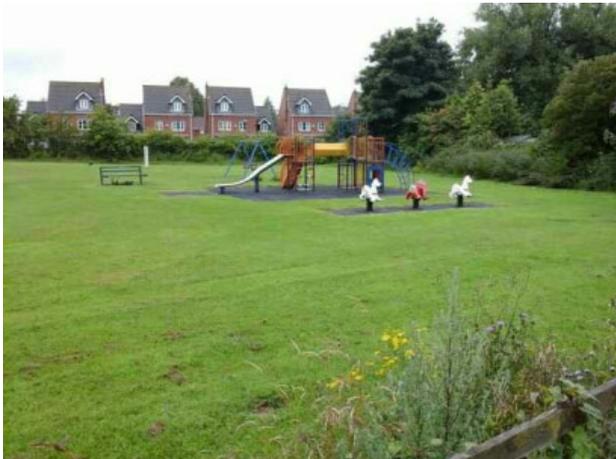
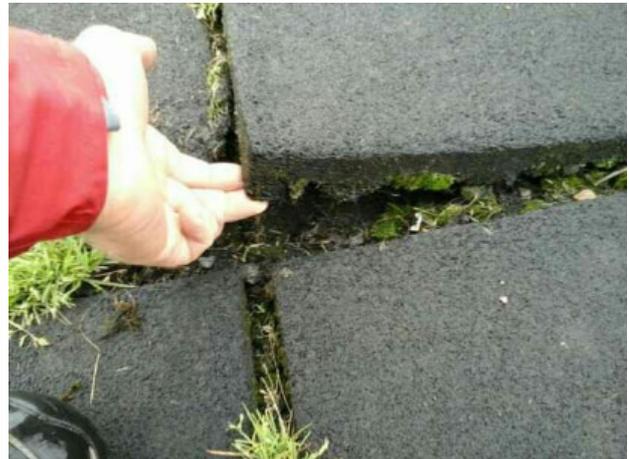
Item: Ancillary Items - Site General
Manufacturer: Owner/Operator

Finding: The tiles can easily be lifted or are lifting along the edges of the area

Action: Lift and re-glue tiles to secure

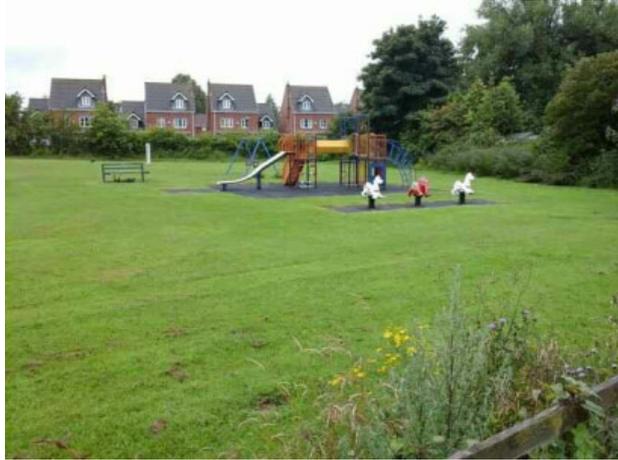
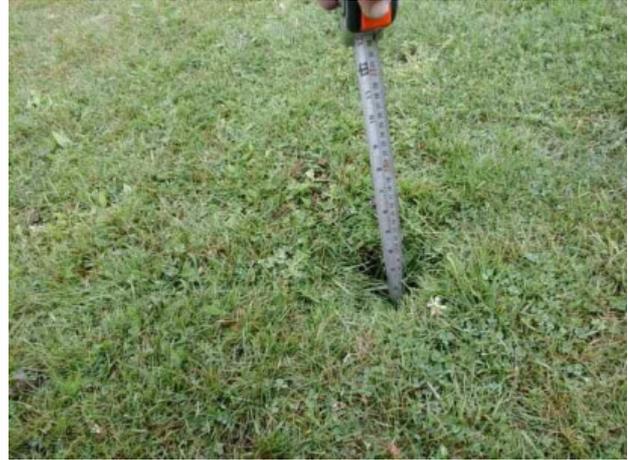
Item: Ancillary Items - Site General
Manufacturer: Owner/Operator

Finding: There are trip hazards present on the football pitch

Action: Regulate levels to remove the trip points

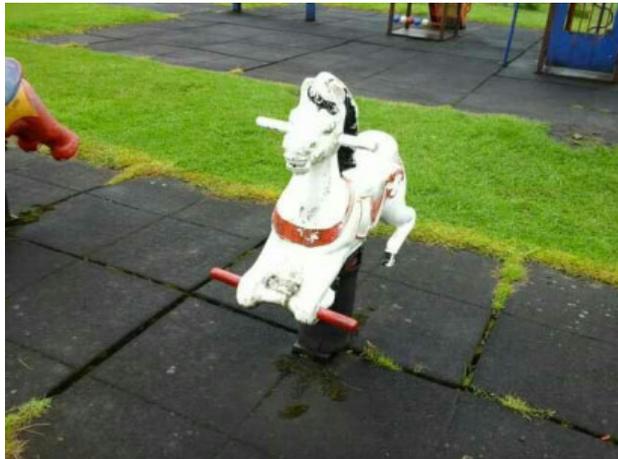
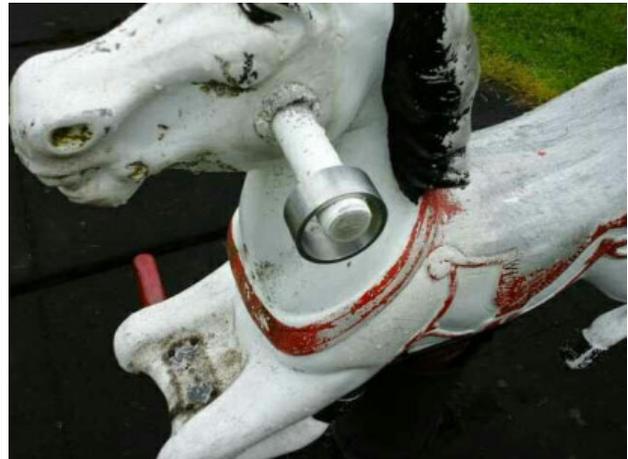
Item: Rocking Equipment - Spring Horse
Manufacturer: Wicksteed Playscapes

Finding: The end of handgrips and/or footrests have a cross section of less than 15cm² and fail to meet the requirements of BS EN 1176:2008 Part 6

Action: This is a relatively low risk failure and no remedial action is recommended

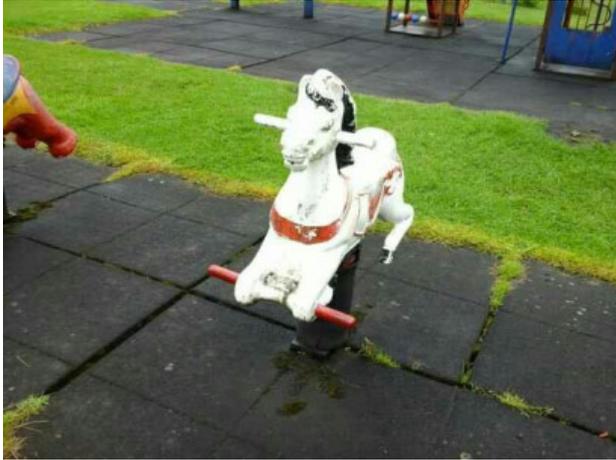
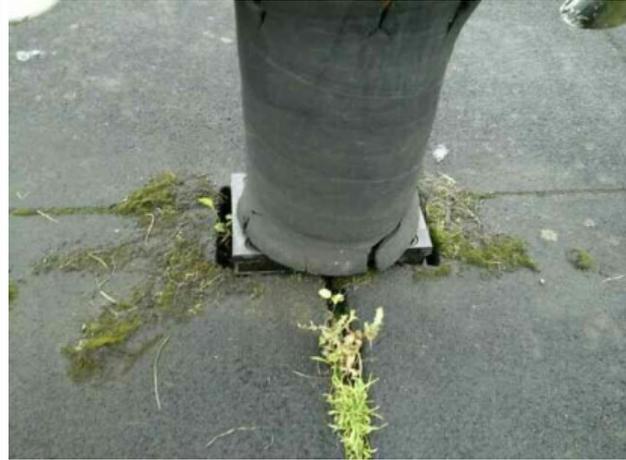
Item: Rocking Equipment - Spring Horse
Manufacturer: Wicksteed Playscapes

Finding: The gaiter is damaged

Action: Monitor for further deterioration and replace as required

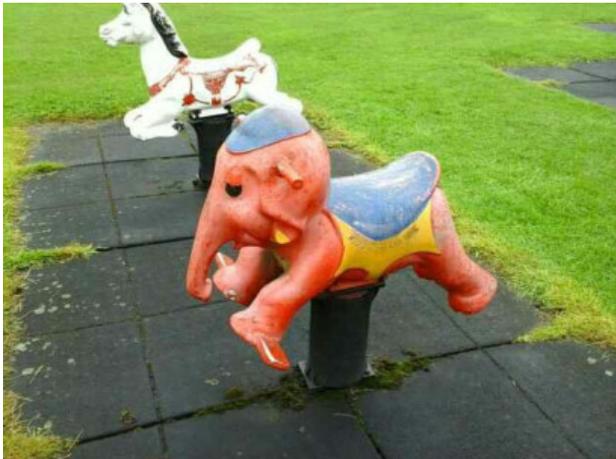
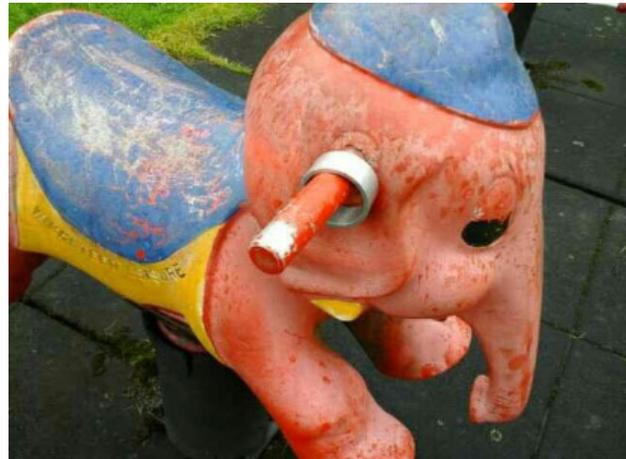
Item: Rocking Equipment - Spring Elephant
Manufacturer: Wicksteed Playscapes

Finding: The end of handgrips and/or footrests have a cross section of less than 15cm² and fail to meet the requirements of BS EN 1176:2008 Part 6

Action: This is a relatively low risk failure and no remedial action is recommended

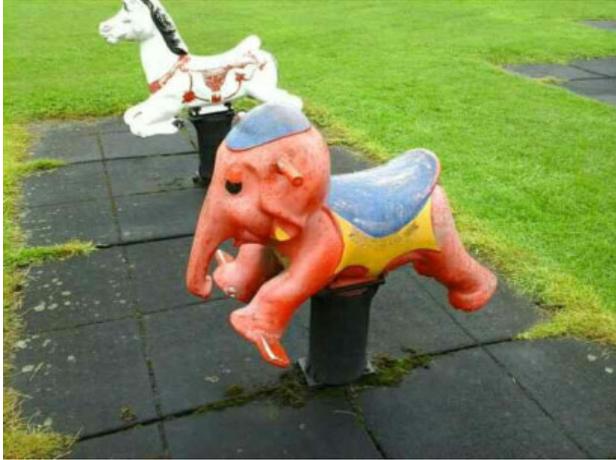
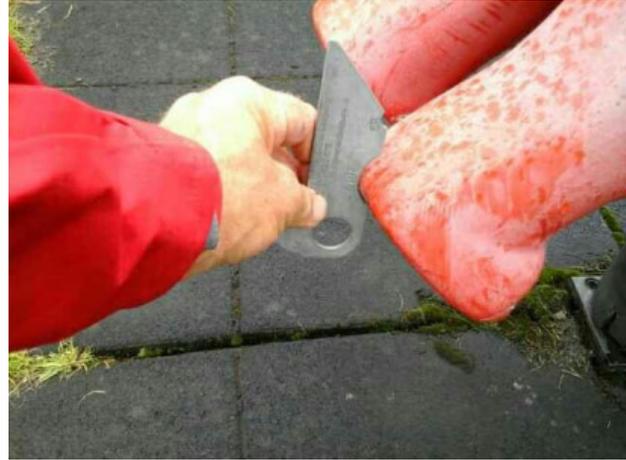
Item: Rocking Equipment - Spring Elephant
Manufacturer: Wicksteed Playscapes

Finding: The main body profile has a radius of less than 20mm in places

Action: Monitor Use

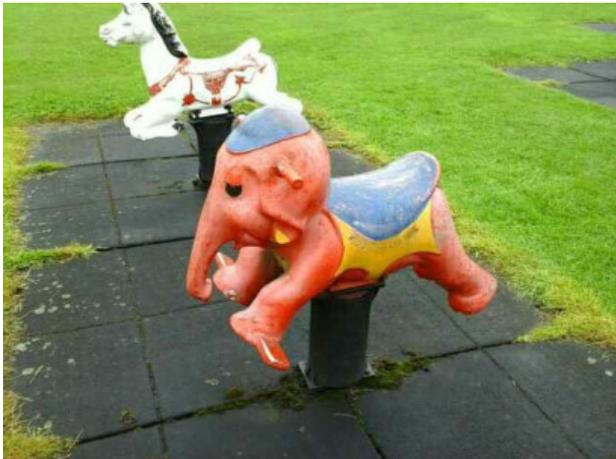
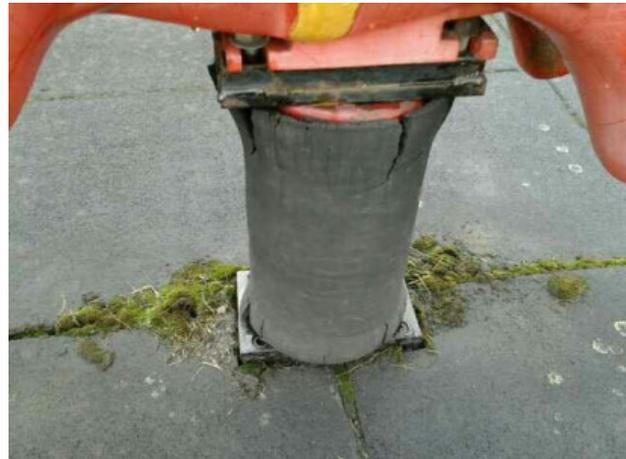
Item: Rocking Equipment - Spring Elephant
Manufacturer: Wicksteed Playscapes

Finding: The gaitor is damaged

Action: Monitor for further deterioration and replace as required

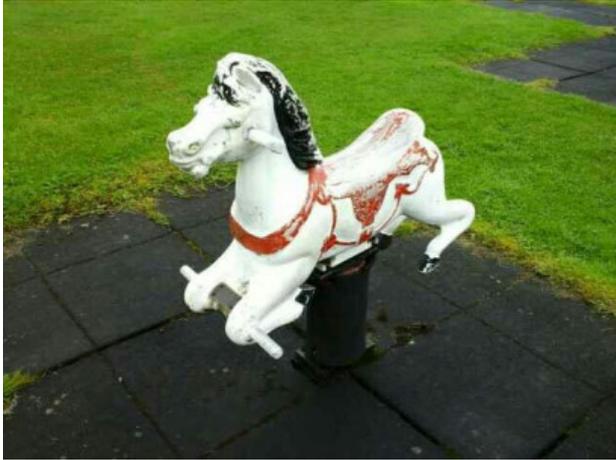
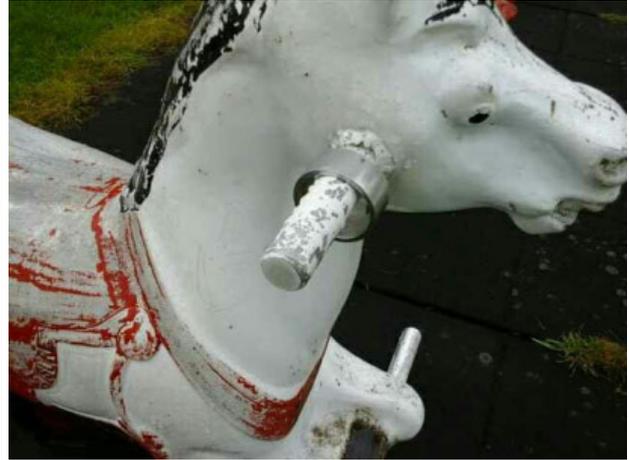
Item: Rocking Equipment - Spring Horse
Manufacturer: Wicksteed Playscapes

Finding: The end of handgrips and/or footrests have a cross section of less than 15cm² and fail to meet the requirements of BS EN 1176:2008 Part 6

Action: This is a relatively low risk failure and no remedial action is recommended

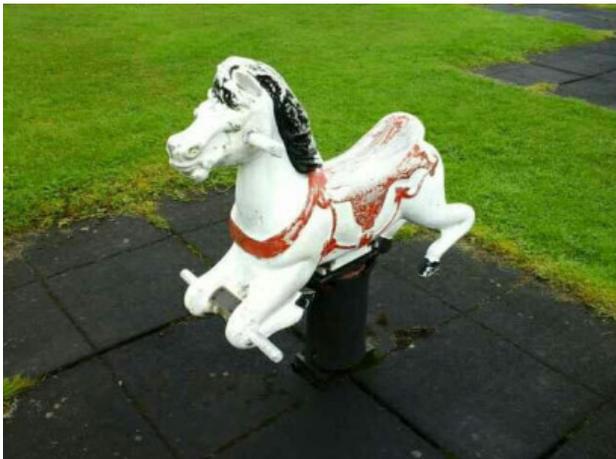
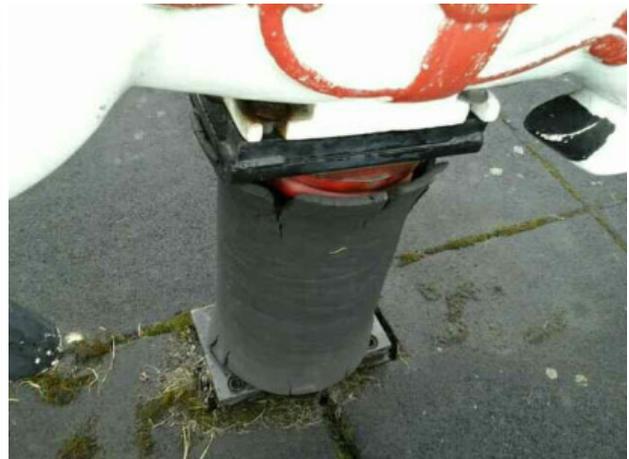
Item: Rocking Equipment - Spring Horse
Manufacturer: Wicksteed Playscapes

Finding: The gaitor is damaged

Action: Monitor for further deterioration and replace as required

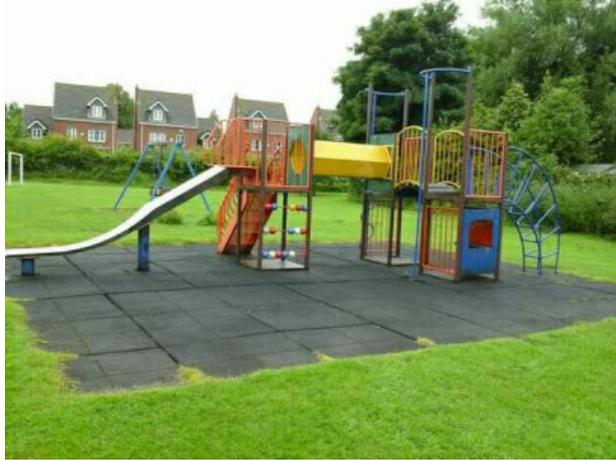
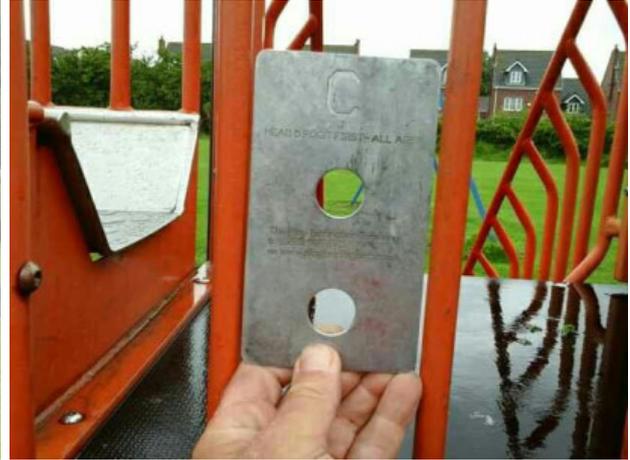
Item: Activity Equipment - Multi Play (Junior)
Manufacturer: Wicksteed Playscapes

Finding: The item fails to meet the requirements of BS EN 1176:2008 Part 1 4.2.7.2 head and neck entrapment in the barriers and/or steps

Action: Monitor use

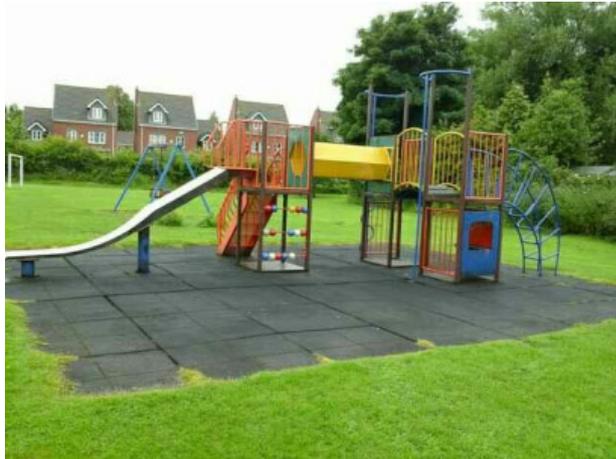
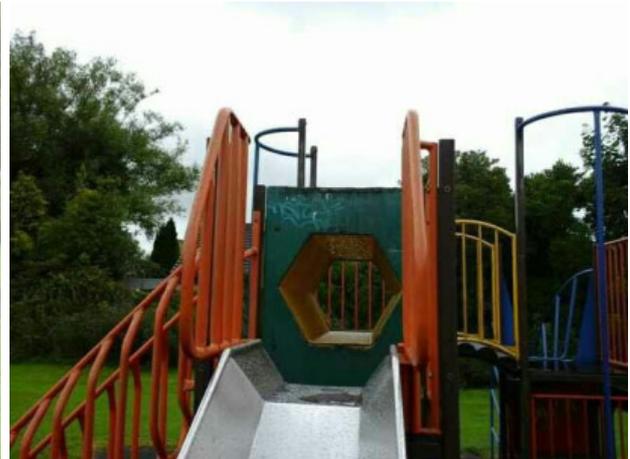
Item: Activity Equipment - Multi Play (Junior)
Manufacturer: Wicksteed Playscapes

Finding: This item has no slide bar fitted as required by BS EN 1176 Part 3

Action: Monitor use

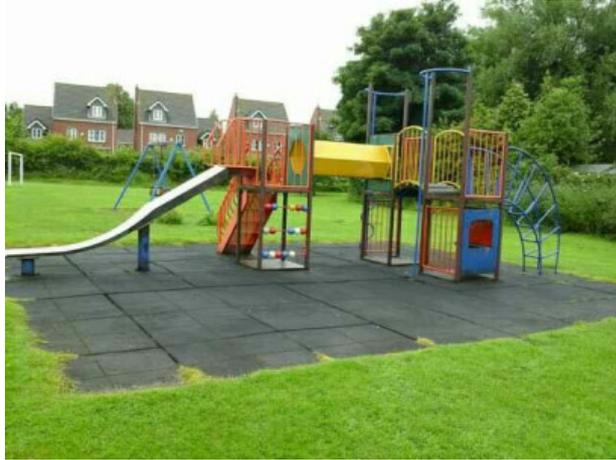
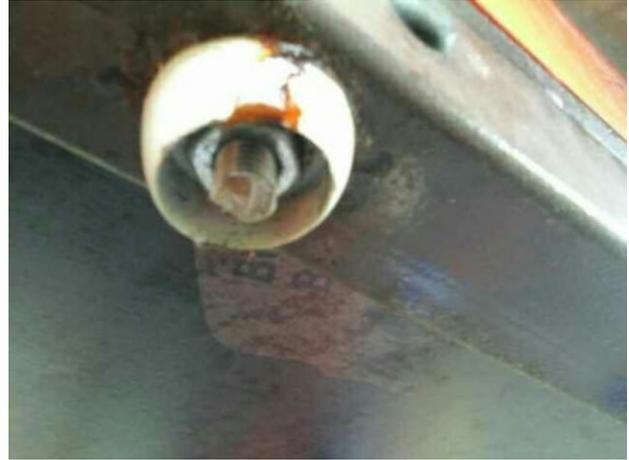
Item: Activity Equipment - Multi Play (Junior)
Manufacturer: Wicksteed Playscapes

Finding: There is/are bolt cap covers missing or damaged on the item

Action: Replace missing or damaged bolt cap covers

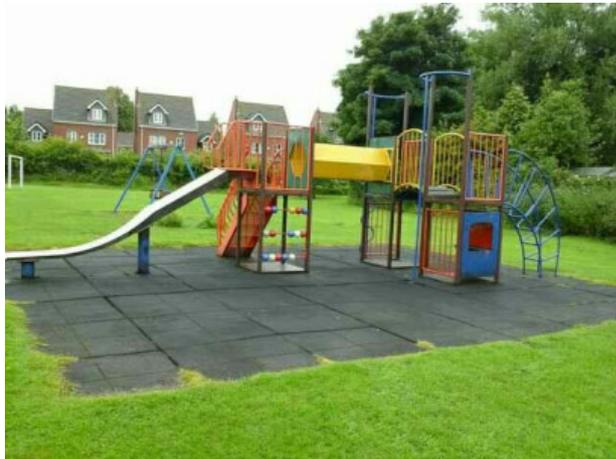
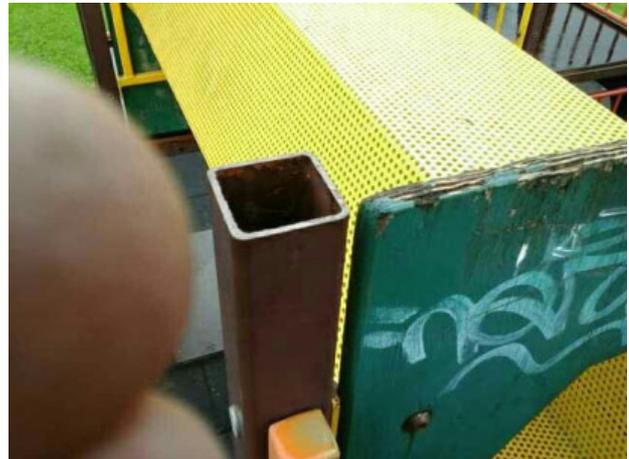
Item: Activity Equipment - Multi Play (Junior)
Manufacturer: Wicksteed Playscapes

Finding: There are post caps missing from the item

Action: Replace missing post caps

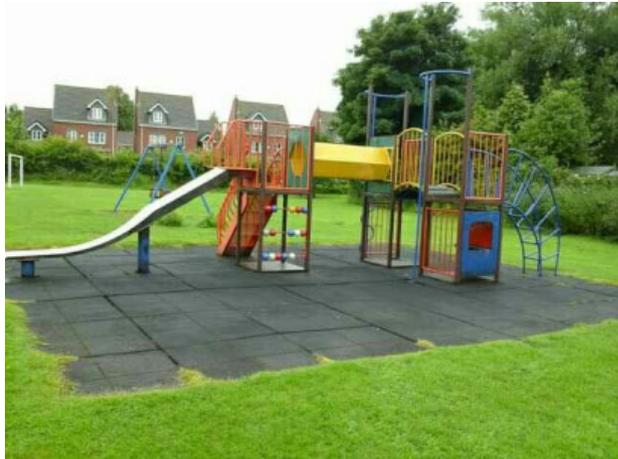
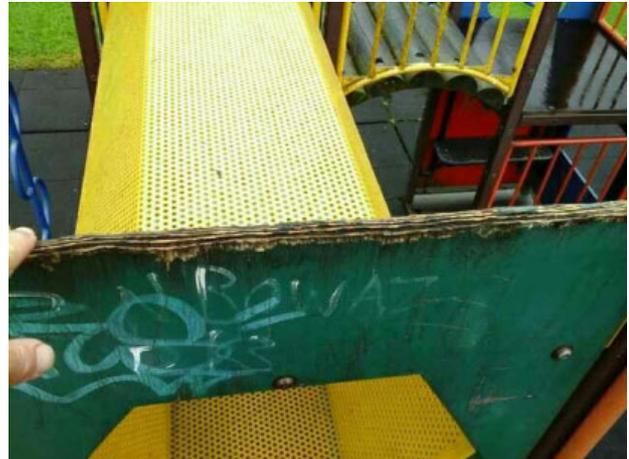
Item: Activity Equipment - Multi Play (Junior)
Manufacturer: Wicksteed Playscapes

Finding: The tunnel guard panels are damaged/worn

Action: Monitor for further deterioration and replace as required

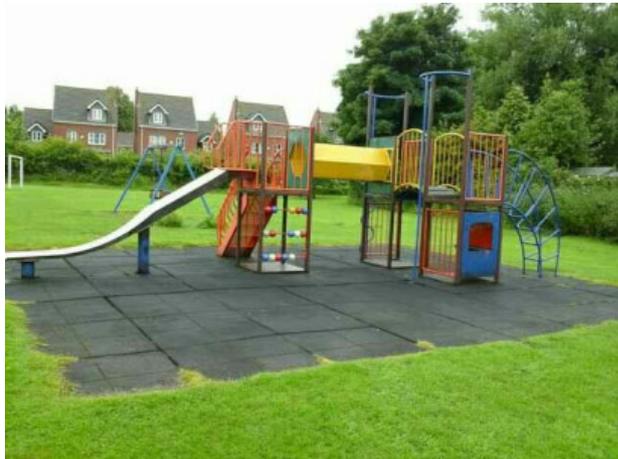
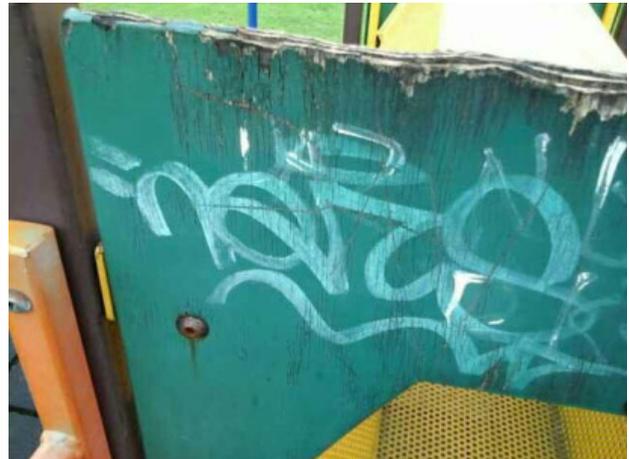
Item: Activity Equipment - Multi Play (Junior)
Manufacturer: Wicksteed Playscapes

Finding: There is some graffiti present

Action: Remove the graffiti

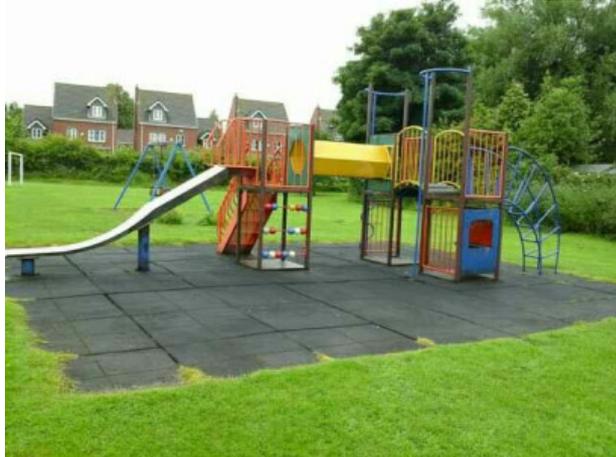
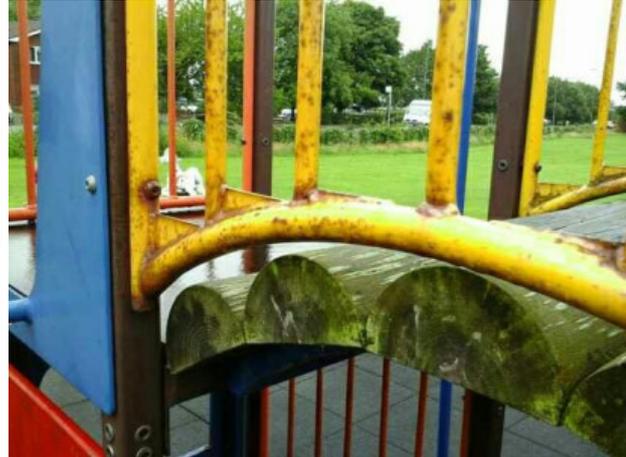
Item: Activity Equipment - Multi Play (Junior)
Manufacturer: Wicksteed Playscapes

Finding: There is surface corrosion present on the item

Action: Consider treating and repainting the item

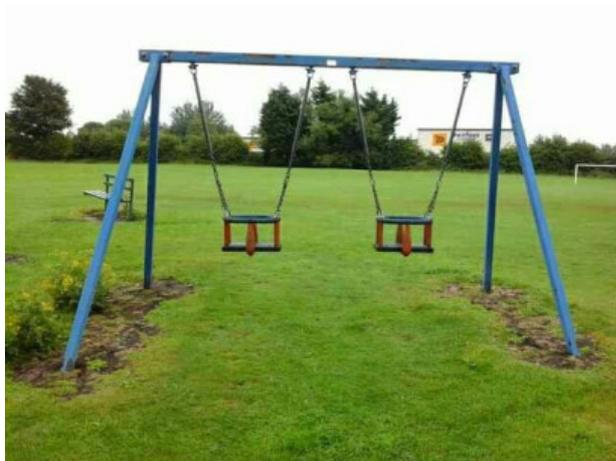
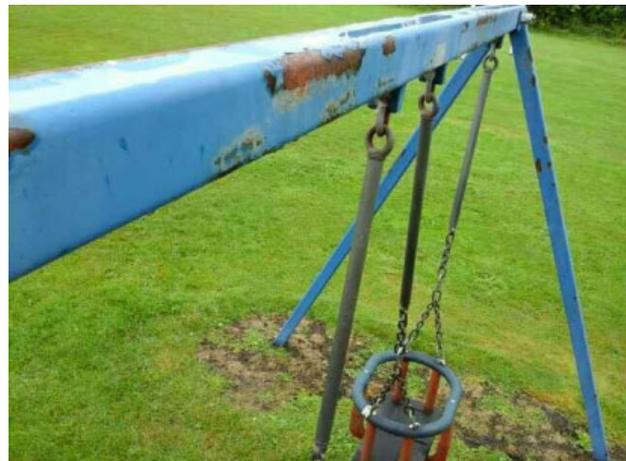
Item: Swings - 1 Bay 3 Seat (Cradle)
Manufacturer: StreetSkapes

Finding: There is surface corrosion present on the item

Action: Consider treating and repainting the item
