Annual Inspection

RSS Playmakers

Abbey Road Playing Field

Annual Inspection - 28 July 2015 at 15:19 Inspector: Richard Goodson RPII Annual Inspector

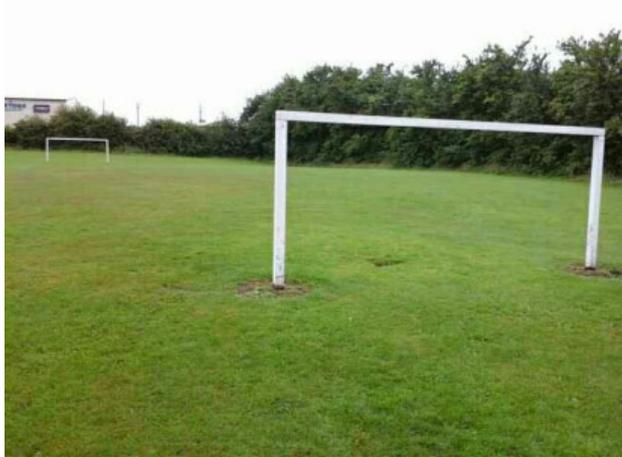
Item: Multi Use Games Area - 5 a side Goals
Manufacturer: Unknown
Surface Type: Grass
Equipment Compliance: N/A
Surface Area Compliance: N/A
Ref/Part Number:
Total Findings: 1

Finding 1

This item is satisfactory - no work required
